INVENTORY FORM FOR STATE HISTORIC SITES SURVEY

Tamlyn House

305 North Commerce Street

QA-142

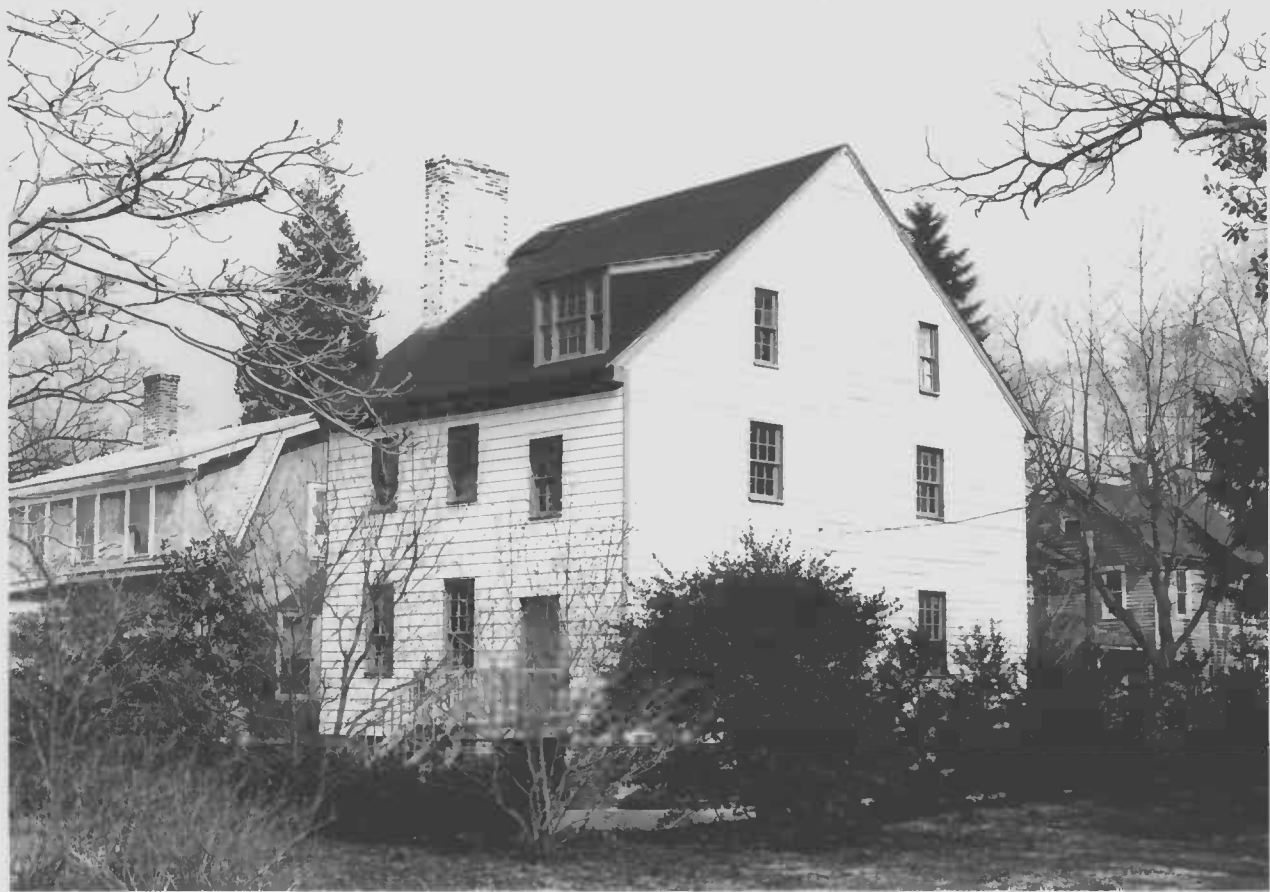
QA-142

Rear facade from Southwest

On the rear facade, the door is in the south bay, with two 9/6 windows to the left, three 6/6 windows on the second floor, and one large shed roof dormer in the south bay on the third floor.

A cellar door is located under the rear entrance porch in the south bay, and two four-light cellar windows are centered under the first floor windows. The south window on the second floor is downset over the stair landing; the third floor dormer is also centered on the stair hall and is fitted with a single 6/6 sash flanked by narrow 2/2 sash on each side. The siding is plain, trimmed with beaded cornerboards; the cornice matches the cornice on the front facade.

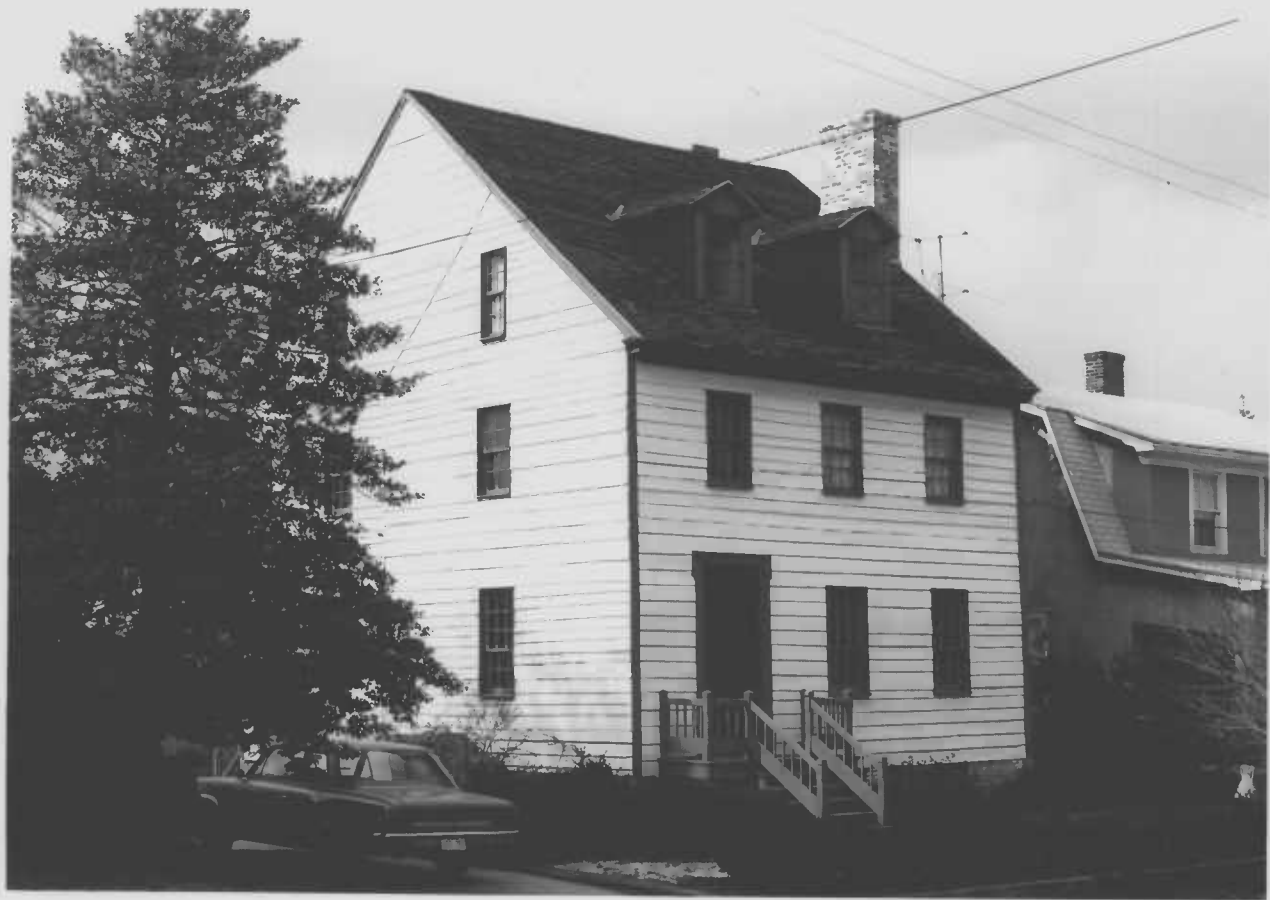
QA-142 Tamlyn Residence
305 North Commerce Street
Centreville, Maryland
Orlando Ridout V 1981
Front facade from Southeast

This frame dwelling house was constructed in two distinct periods. The original house was 2 1/2 stories high on a full brick cellar, three bays wide and one room deep with a single flush brick chimney centered on the north end of the pitched gable roof. It was later enlarged to the rear, forming a double pile house, still 2 1/2 stories high but with considerably more space on the third floor. The front facade faces east to Commerce Street. The door is located in the south bay, with two 9/6 windows to the right and three 6/6 windows on the second floor. There are two 6/6 pitched roof dormer windows on the third floor and a pair of four-light cellar windows directly below the first floor windows.

The foundation is laid in three-course bond; the exterior siding consists of random-width horizontal weatherboards with the lower edges roughly beveled. The six-panel front door and four-light transom above are framed with a crossetted

architrave with an ogee/astragal backband. The eaves are finished with a box cornice trimmed with a complex crown mold and bed mold. Other trim includes the beaded cornerboards and pedimented dormer gables.
